Reserve Study Project No. 10014

Prepared for Miller Ranch Property Owners' Association Edwards, Colorado

> > November 18, 2010

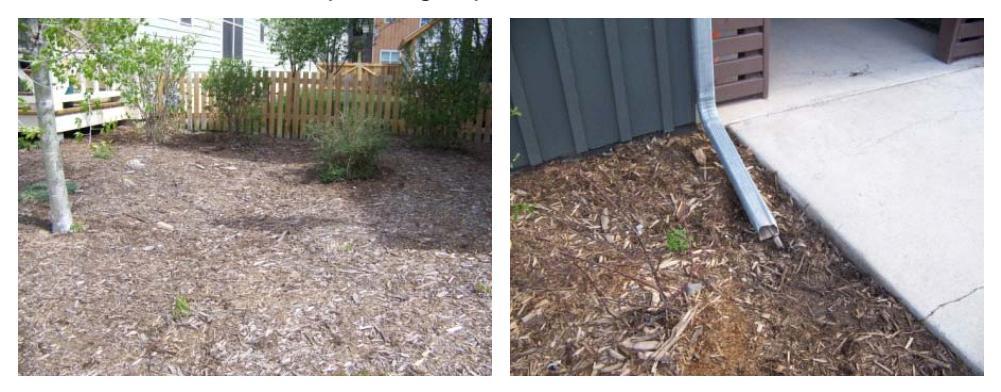
A1. Site and Building Grading and Drainage

Condition: The building grading and drainage is in good to fair condition. We noted that most of the buildings have sufficient slope away from the building foundations however, there are several buildings where the surface slope is flat and/or sloped towards the building foundation, the condo buildings in particular. For the condos, it is recommended that perforated piping be installed in place of downspout extensions and discharge the stormwater runoff, via the piping, to the landscape areas away from the foundations of the buildings. This expense will not be included in this Study since it is considered the responsibility of the Miller Ranch Condominium Association and it will be noted in that Association's Study. It is recommended that the Property Owners' Association maintain and regrade the earthen areas adjacent to the foundations to all the buildings in the Miller Ranch Community. The site grading and drainage in common landscape open areas are in good condition.

- Cyclically regrade and maintain a portion of the earthen areas adjacent to the building foundation system every 8 years, starting in 2012.
- Cyclically check and clean debris from the inlets to ensure proper function every year. This cost
 is not included in the Study because normally associations perform this as a maintenance item
 and the cost is considered an operating expense.

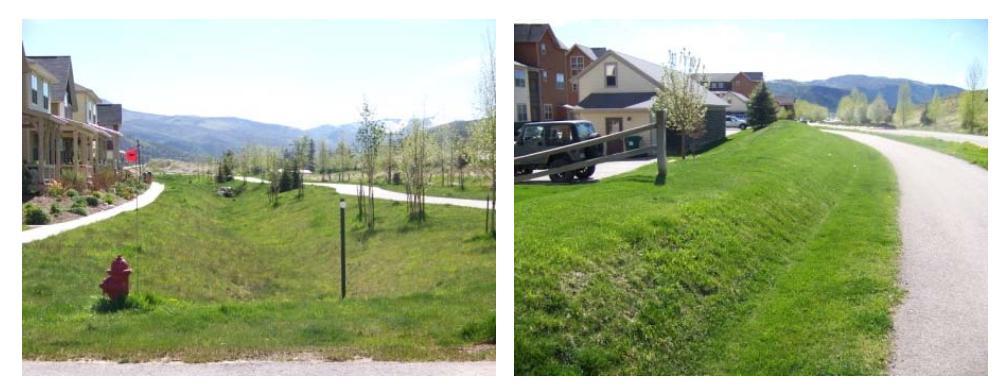
A2. Detention Basins

Condition: Good to fair condition. We were informed by the Property Owners' Association that there are drainage issues relating to snowmelt and the drainage of the snowmelt associated with the southwest drainage basin, adjacent to the south perimeter of the community. The Association informed us the snowmelt water ponds on the concrete apron due to insufficient drainage slope to the basin. We noted within the southwest detention basin that the grass swale lacks sufficient slope to convey runoff water effectively. We recommend a drainage study be performed on the detention area in order to provide a proper design to promote positive drainage.

- We recommend that a drainage study be performed on the southwest detention basin in 2011 to determine the best engineered solution to convey runoff/snowmelt water effectively to the detention basin. Engineering fees are included in this component action.
- Cyclically check and clean debris from the culvert pipes to ensure proper function every year. This cost is not included in the Study because normally associations perform this as a maintenance item and the cost is considered an operating expense.
- Cyclically inspect any erosion or instability of the slopes, clear excessive sedimentation build-up in the basin, monitor settling at bermed areas, and monitor the grass swale conveyance to ensure proper function every year. This cost is not included in the Study because normally associations perform this as a maintenance item and the cost is considered an operating expense.

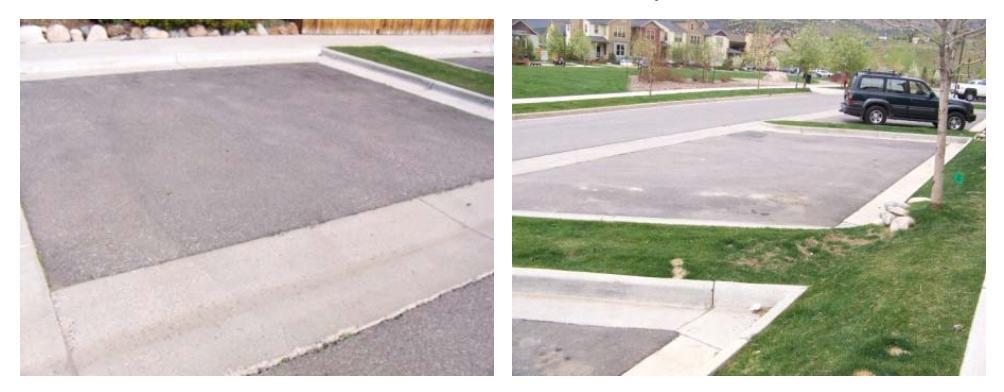
B1. Asphalt Drive and Parking Areas

Condition: Good condition with low grade raveling/weathering and distortion.

- Cyclically seal coat and crack fill of the asphalt surface every 3 years, starting in 2012.
- Mill and overlay and/or full depth patch replace the asphalt associated with the parking areas every 18 years, starting in 2027. Prior to this work, we recommend contacting an engineer to recommend the most cost-effective way to perform the work, i.e., some areas of the asphalt may need full depth patch replacement; and other areas may need to be milled and overlaid. Engineer evaluation fees have been included in this component.

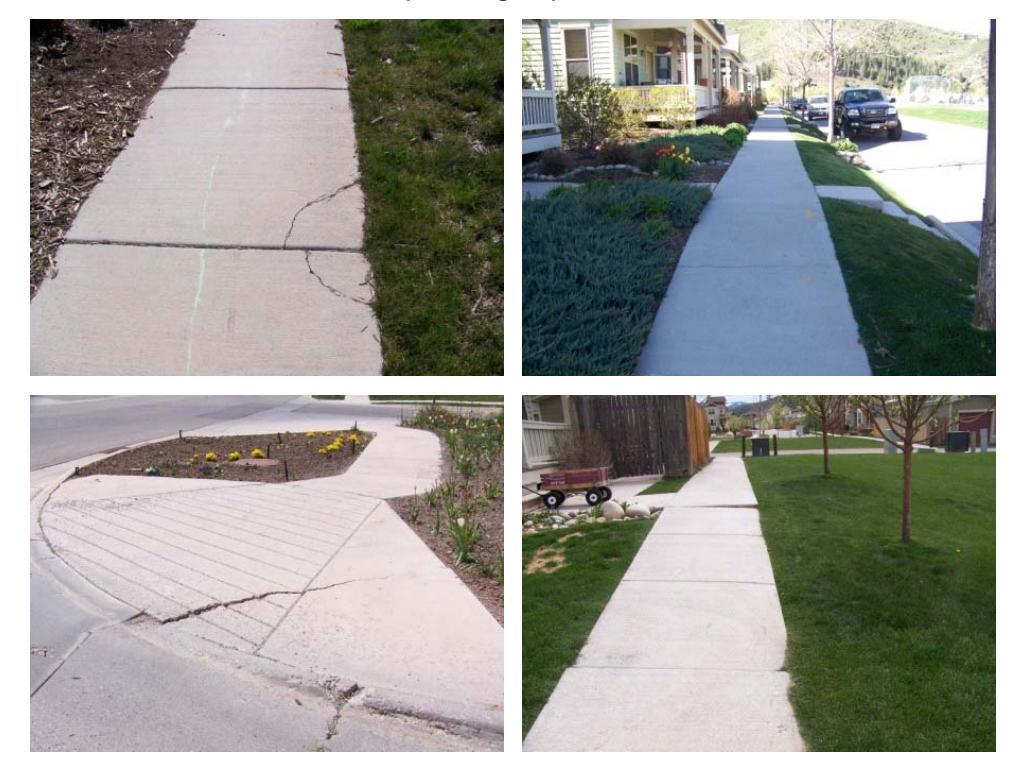
C1. Concrete Walkways

Condition: Fair condition with extensive cracking and/or deterioration noted. Some of the cracked areas have settled or heaved resulting in differential edges, which can be a tripping hazard if not corrected. We were informed that the Miller Ranch Property Owners' Association has capital improvement projects for 2011 that include extensive sidewalk repair and replacement.

- Cyclically remove and replace damaged sections of the concrete walkways every 3 years, starting in 2014.
- Inspect the surface and repair any cracks or deteriorating concrete walkways every year. This cost is not included in the Study because normally associations perform this as a maintenance item and the cost is considered an operating expense.

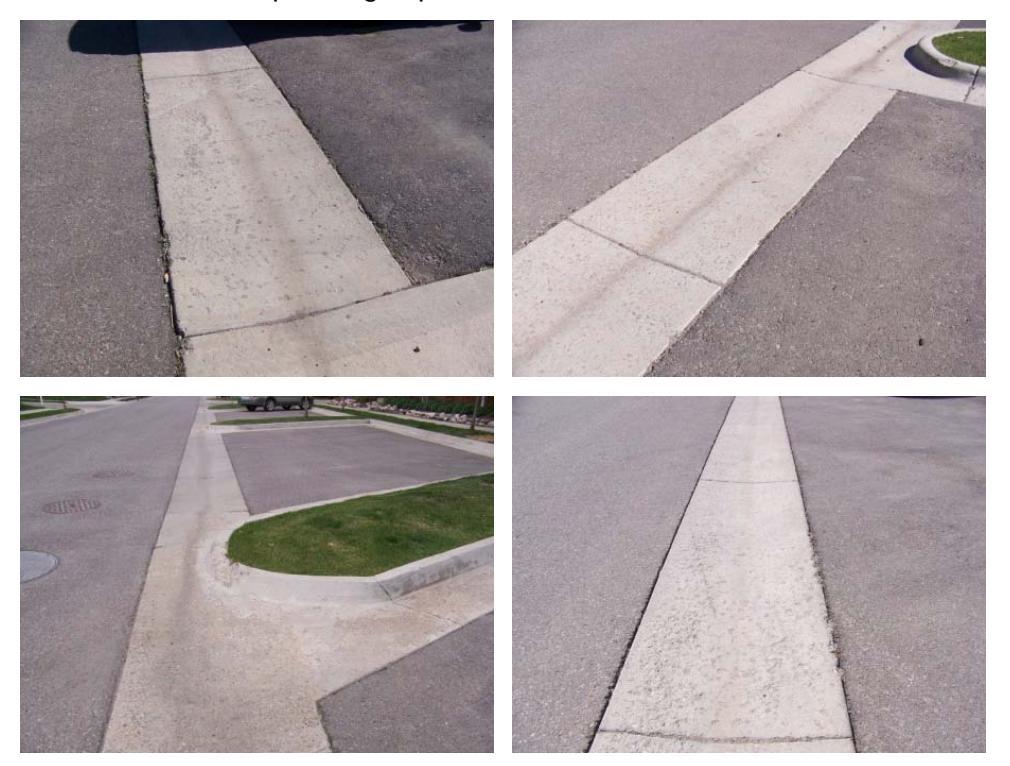
C2. Concrete Drain Pan

Condition: Good to fair condition with minor cracking and moderate deterioration noted.

- Cyclically remove and replace of the damaged sections of the concrete pan every 6 years, starting in 2014.
- Inspect the surface and repair any cracks or deteriorating concrete pan every year. This cost is
 not included in the Study because normally associations perform this as a maintenance item and
 the cost is considered an operating expense.

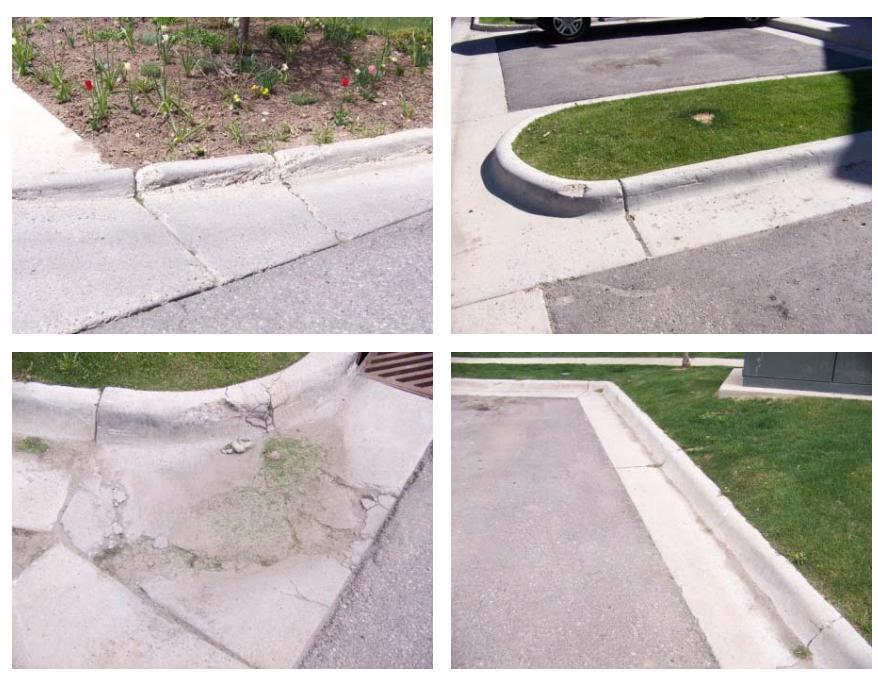
C3. Curb and Gutter

Condition: Good to fair condition with areas of significant cracking, deterioration, and damaged sections noted. Most of the damage to the curb and gutters within the Miller Ranch community are mainly from the heavy use of snow-traction aggregate and chemicals along with snow plowing operations. We were informed that the Association is responsible for the curb and gutters associated with the parking areas. We were requested by the Property Owners' Association to include a budget option for all the curb and gutters within the Miller Ranch community, except for curb and gutter associated with the Condominium Association, because it is unclear to the Association if the curb and gutter associated with the streets is the responsibility of the Association or Eagle County. The curb and gutter located adjacent to the roads have been included in this report for informational purposes only and are not included in the financial projections.

- Cyclically remove and replace the damaged sections of the concrete curb and gutters every 6 years, starting in 2011.
- Informational only Cyclically remove and replace the damaged sections of the concrete curb and gutter every 6 years, starting in 2011.
- Inspect the surface and repair any cracks or deteriorating concrete curbs every year. This cost is not included in the Study because normally associations perform this as a maintenance item and the cost is considered an operating expense.

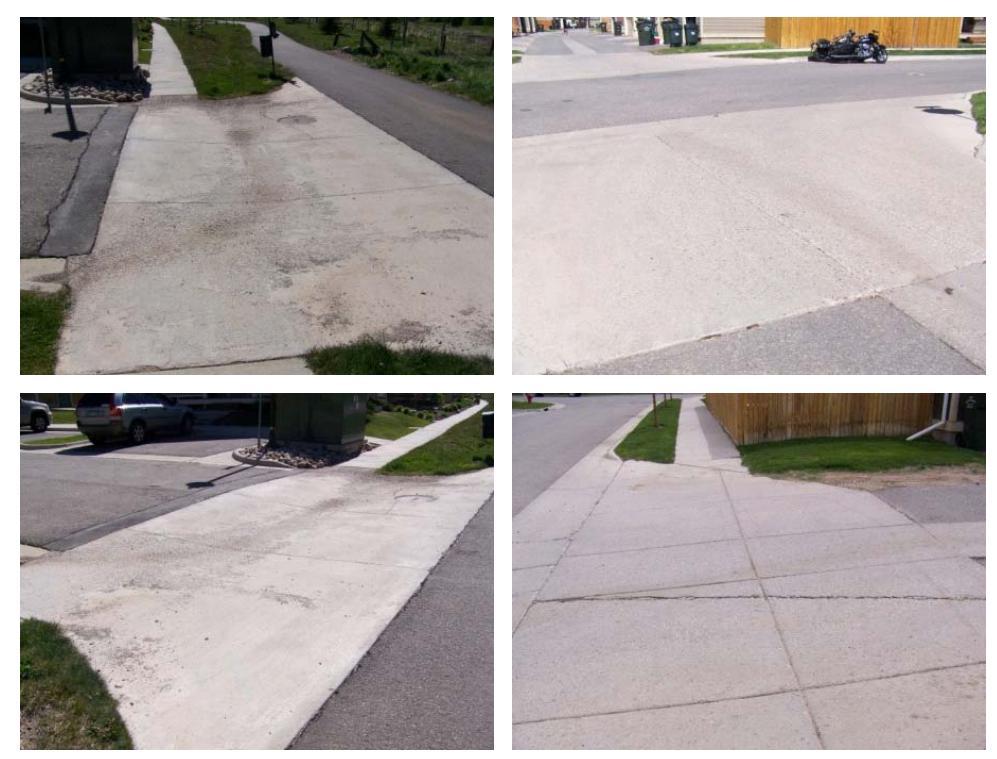
C4. Concrete Approaches - Option

Condition: Good to fair condition with significant cracking and/or deterioration noted in areas. We were requested by the Property Owners' Association to include a budget option for all the concrete approaches within the Miller Ranch community because it is unclear to the Association if the concrete approaches associated with the alleys is the responsibility of the Association or Eagle County. The concrete approaches have been included in this report for informational purposes only and are not included in the financial projections.

- Informational only Cyclically remove and replace the damaged sections of the concrete approaches every 6 years, starting in 2011.
- Inspect the surface and repair any cracks or deteriorating concrete curbs every year. This cost is
 not included in the Study because normally associations perform this as a maintenance item and
 the cost is considered an operating expense.

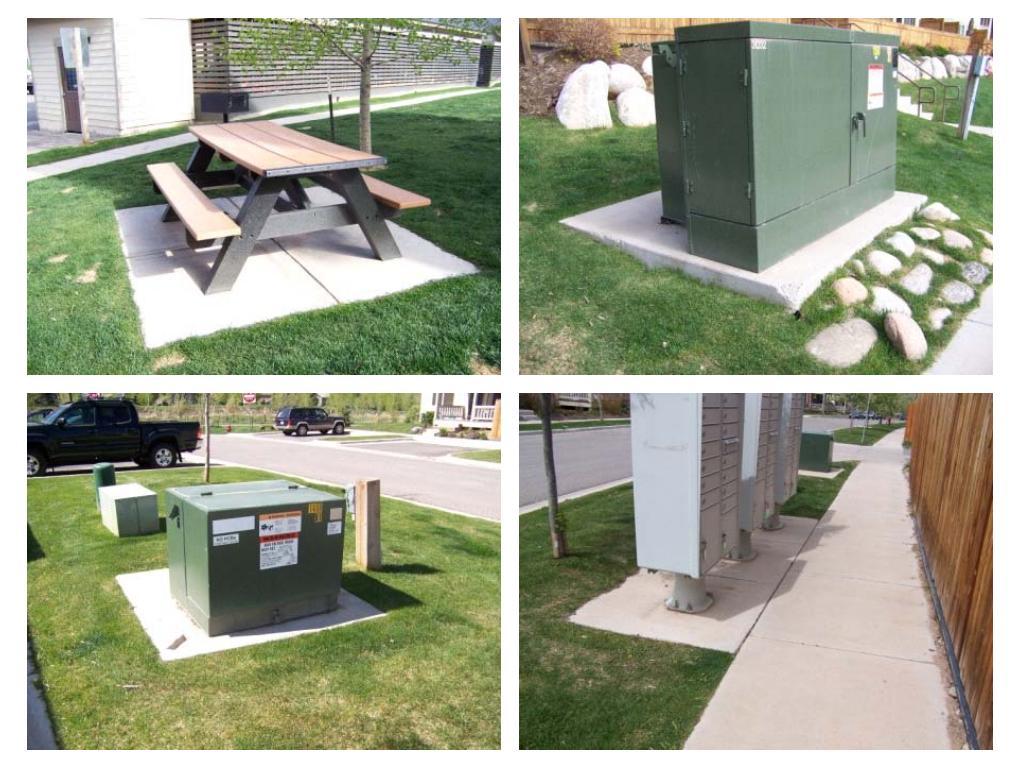
C5. Concrete Slabs

Condition: Good condition with no significant cracking and/or deterioration noted.

- Cyclically remove and replace the damaged sections of the concrete slabs every 6 years, starting in 2017.
- Inspect the surface and repair any cracks or deteriorating concrete slabs every year. This cost is not included in the Study because the cost to perform this action is below the minimum threshold of this Study.

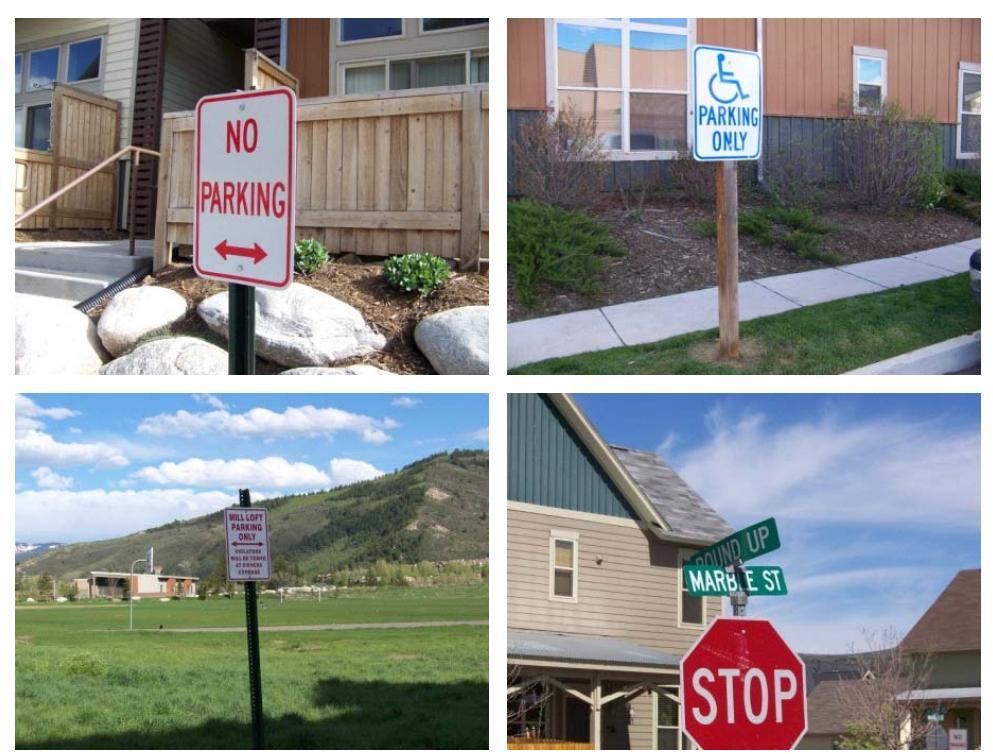
D1. Community Signs

Condition: Good condition.

• Inspection and replacement of address, street, and no parking signs are done on an as needed basis. The cost is not included in the Study because it falls below the minimum fund threshold.

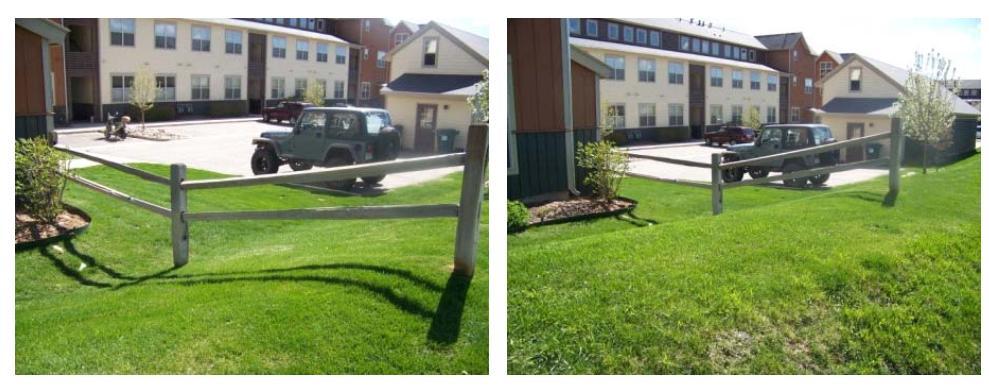
D2. Split Rail Fence

Condition: Good condition.

• Cyclically remove and replace the split rail fencing every 15 years, starting in 2018. This cost is not included in this Study because the removal and replacement cost is below the minimum threshold of this Study.

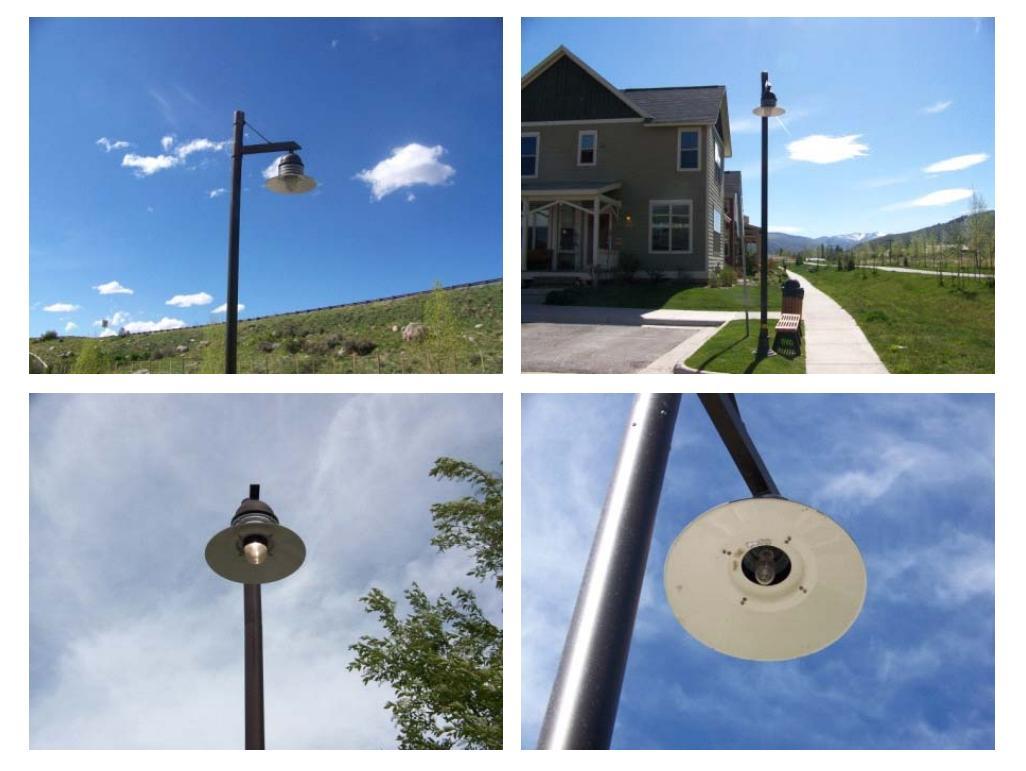
D3. Street Lights

Condition: The site observation was performed during the day, so we cannot verify if lights are in good working condition but aesthetically are in good condition. We were informed by the Association that 90% of the ballasts associated with the lights were replaced in 2009-2010.

- Cyclically remove and replace street light ballasts every 5 years, starting in 2016.
- Remove and replace the street lights in 2029.

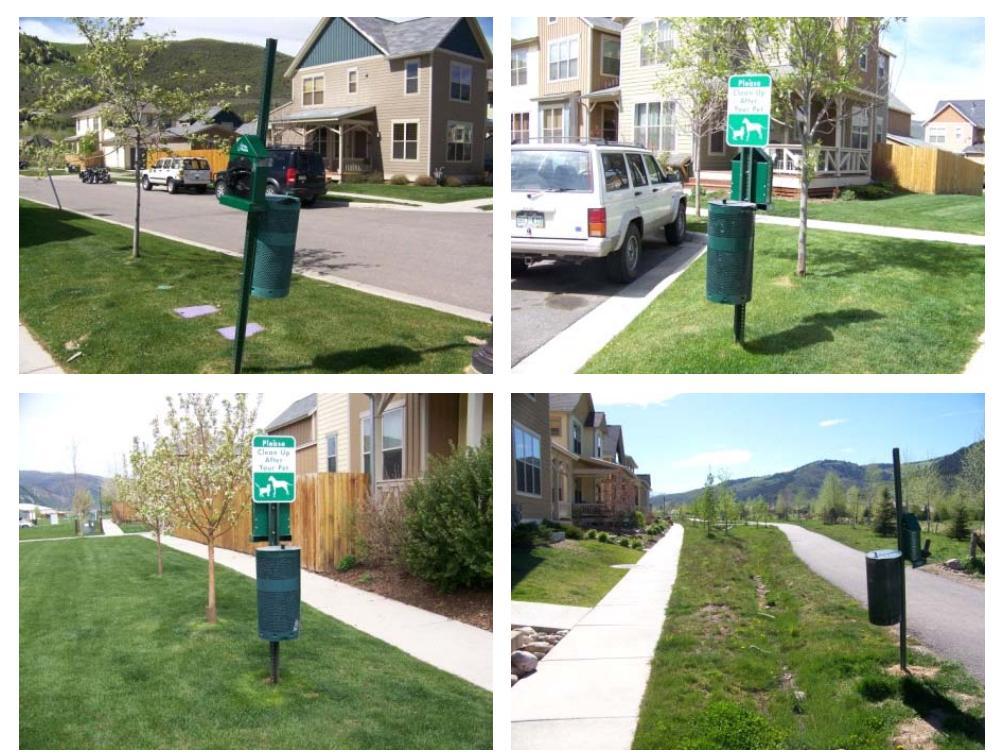
D4. Pet Stations

Condition: Good to fair condition. It was noted that several dog station posts are leaning and/or damaged, most likely due to snow storage from the snow removal during the winter months.

• Cyclically remove and replace a portion of the pet stations every 3 years, starting in 2016.

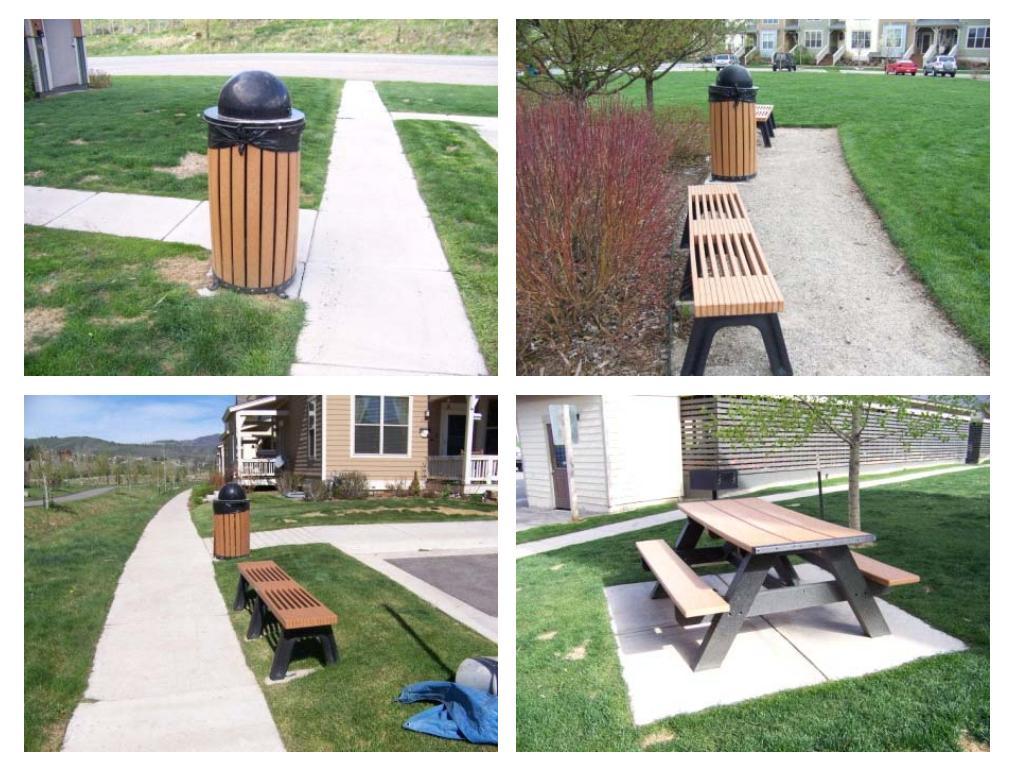
D5. Site Furniture

Condition: Good to fair condition. It was noted that there are several trash receptacles with missing and/or damaged vertical slats.

• Remove and replace a portion of the benches, trash receptacles, tables every 7 years, starting in 2014.

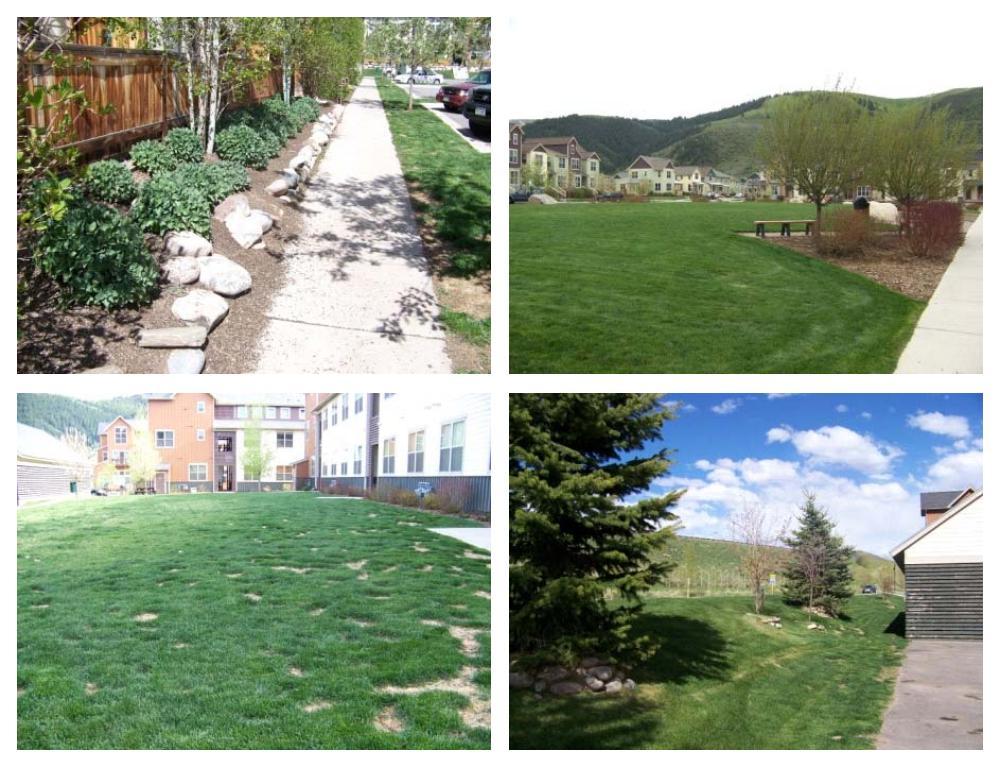
D6. Vegetation

Condition: Good to fair condition with several areas of spotty grass from domestic animals. We were informed that the Property Owners' Association maintains all landscape within the community which includes landscaping associated with the townhomes and condos. We were also informed there is landscape budget within the annual budget and that costs associated with landscaping/vegetation regarding the reserve study should be minimal.

- Complete the last year of work from the Association's two-year project in 2011.
- Cyclically remove and replace the diseased or dead trees, plants, and grass cover every year, starting in 2011.

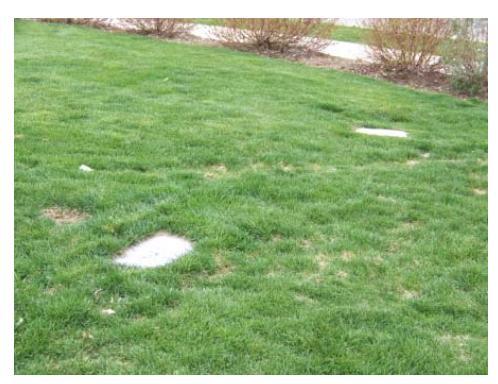
D7. Irrigation System

Condition: Presumed in good condition.

• The irrigation is maintained every year through the operating budget.
